UNITED STATES ENVIRONMENTAL PROTECTION AGENCY

Re: Approval of RCRA Facility Investigation Release Assessment
Final Report

This report presents the results of an RFA conducted under the RCRA corrective action authorities of the Hazardous and Solid Waste Amendments (HSWA), and as a requirement of the Underground Injection Control Permit for the Detroit Coke Corporation which is located at 7819 West Jefferson Avenue in Detroit, Michigan. The U.S. EPA identification number for the facility is MID 099 114 704.

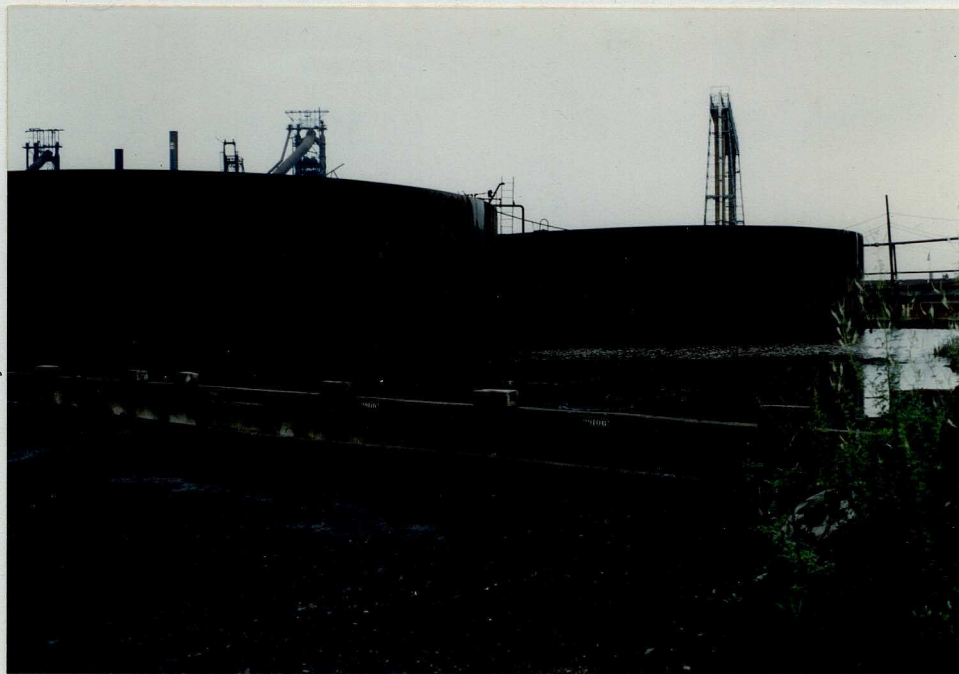
17. *13 Tar Storage tank, + *12, + 10
 - used for tar storage (Photo 24)
 - ~200,000 , , 125,000
 - conc. containment w/ 4' wall,
 - ~12-18 in freeboard left, rest
 filled w/ tar + water (200,000 gal Tar)
 - tanks empty except for
 some poss. tar + water in *10
 - much rusting of tanks
 - riveted construction.
 - containment gets more
 - rainwater → byproducts → deep well

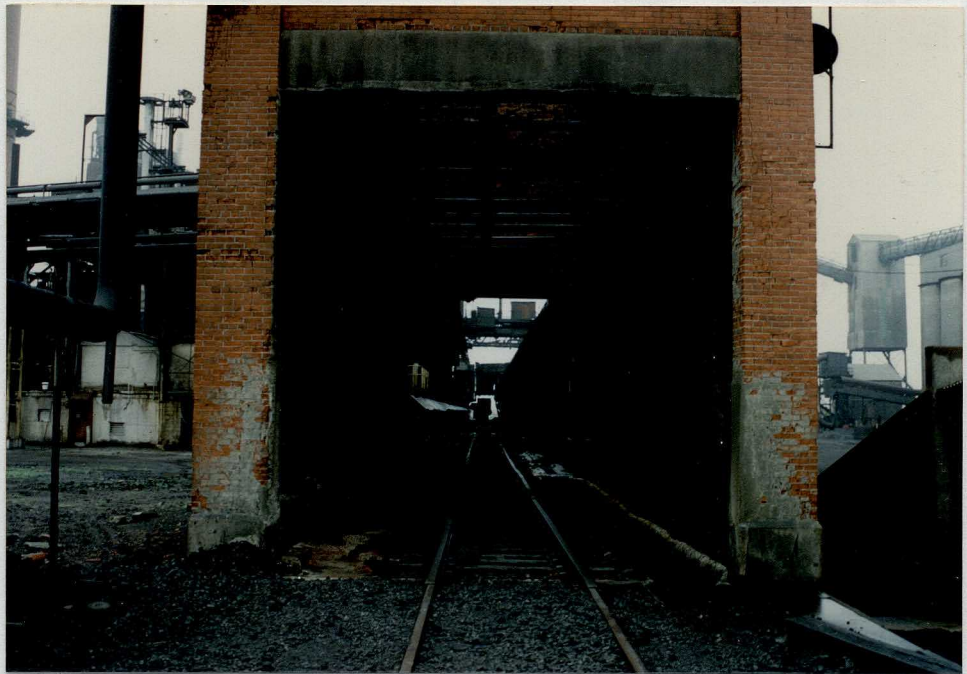
- brick structure ~40-50' high
- conc. floor sloped to catch run-off & divert to recycle sump #7.
- conc. floor stained & piles of coke present
- built w/ #4 battery - 1991
- water discharged from overhead piped onto quench car.
- pipes connected to overhead tank
- water flowed through conc. trough w/ steel plate covers.

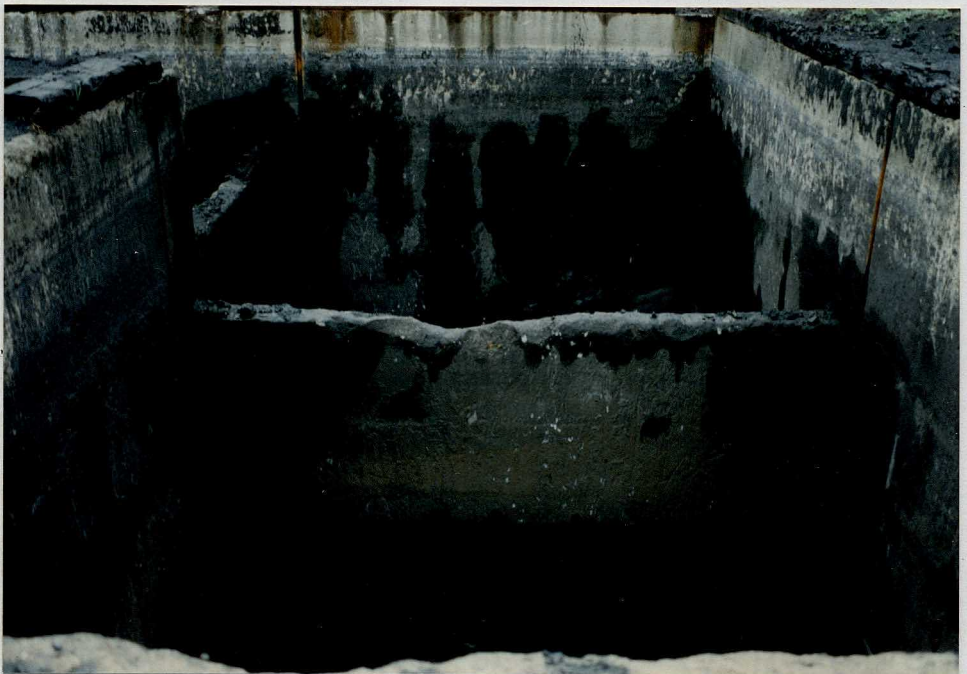
- concrete basin w/ 4 chambers
- coke/coal fines on pad.
- ~ 18'-20' ft deep
- coke fines settled out here
- breeze was clam shelled out daily & placed on adjacent conc. pad w/ ~ 2' curbs in bad shape.
- presently has rainwater w/ oily sheen.
- staining on concrete & breeze in bottoms
- late 60's - 1991
- adjacent pad drains back into sump
- water TC non-haz.

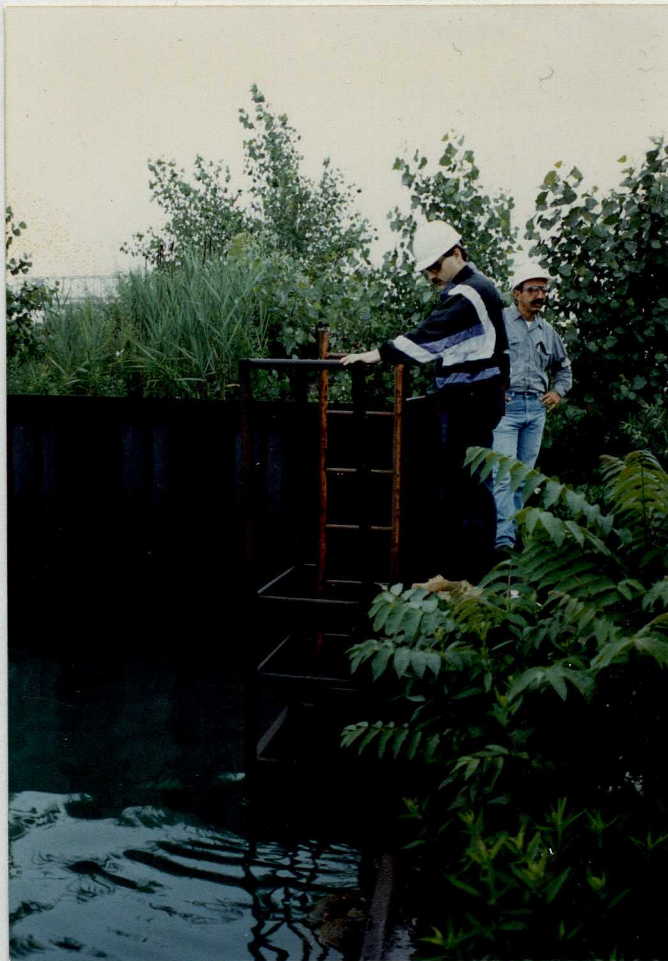
2. Outfall 001 (Photo 1)
- used for non-contact cooling water 4-5 mgd.
- startup - 1991
- may have been a leak in spiral heat exchanger → ammonia excursion.
- absorbent material stored behind sheet piling.

2. Infall 001 - was non-contact cooling water - is shutdown now. used to be ~ 4 million gal./day. now closed back in 70's had leak in line, led to ammonia excursion, was fixed in 70's. took photo Roll 1 shot 1

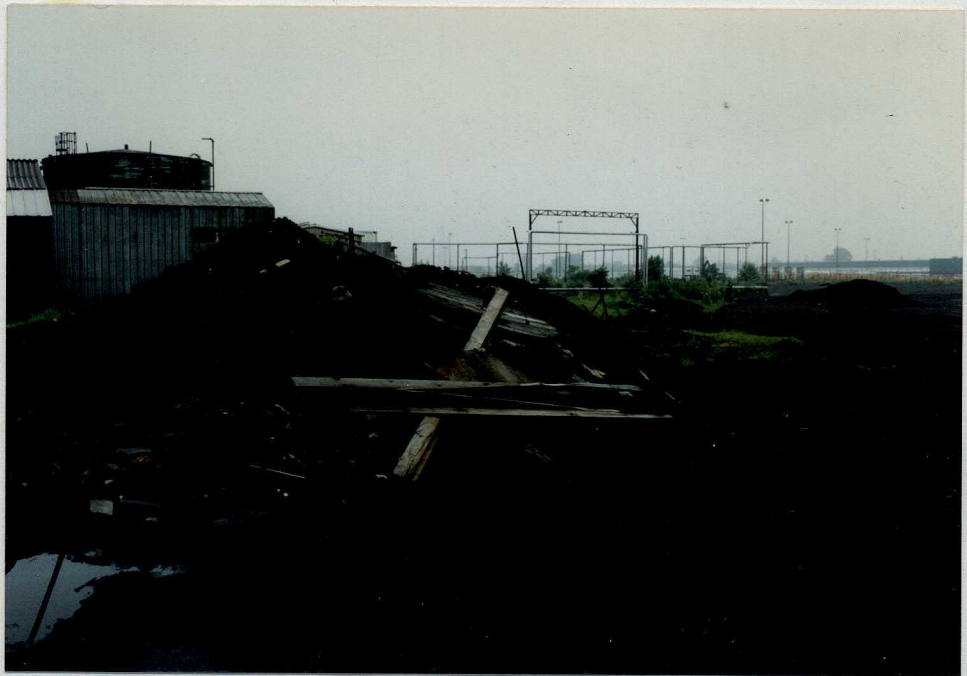
PROJECT/CASE NO: Detroit Coke VSI
SUBJECT: AOC 10
LOCATION: Former pile area
CITY: Detroit COUNTY: Wayne STATE: MI
DATE: 7/15/92 TIME: 8:00 am - 5:00 pm
WEATHER: (SUN) (HAZE) (CLOUDY) (RAIN) (SNOW)
PHOTOGRAPHER (Sig.) Allen Melton
WITNESS: Gregory A. Rudloff
CAMERA: Freedom
FILM TYPE: K. Gold ASA 200 T: 1/ f:
NEGATIVE LOCATION: U.S. EPA FILE #:
PROCESSED BY: Graffoto
PHOTO #: 47 of 54

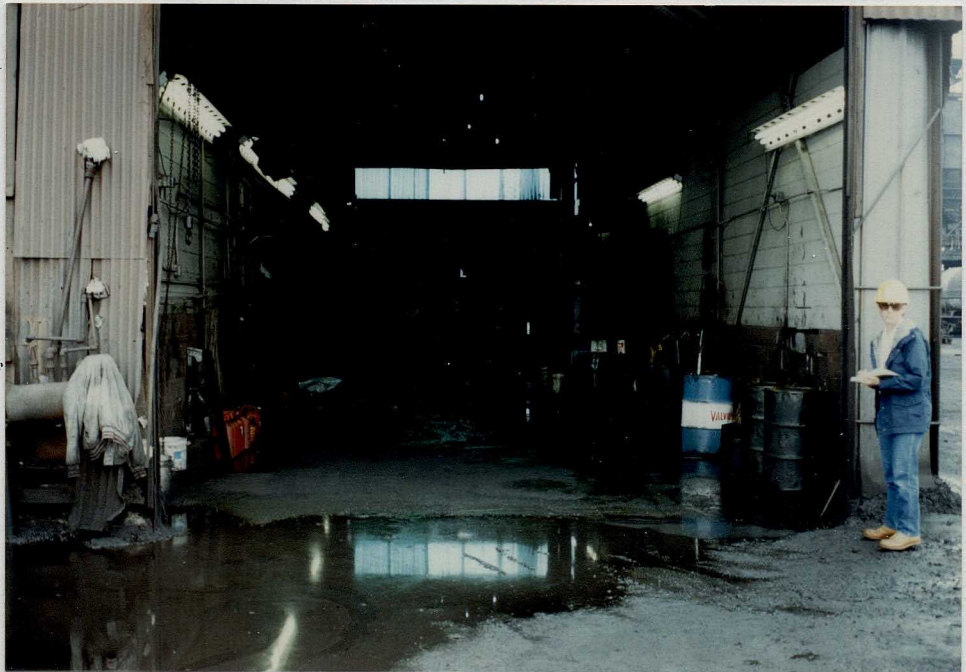
PROJECT/CASE NO: Detroit Coke VSI
SUBJECT: AOC 11
LOCATION: Vehicle maintenance building
CITY: Detroit COUNTY: Wayne STATE: MI
DATE: 7/15/92 TIME: 8:00 am - 5:00 pm
WEATHER: (SUN) (HAZE) (CLOUDY) (RAIN) (SNOW)
PHOTOGRAPHER (Sig.) Allen Melton
WITNESS: Gregory A. Rudloff
CAMERA: Freedom
FILM TYPE: K. Gold ASA 200 T: 1/ f:
NEGATIVE LOCATION: U.S. EPA FILE #:
PROCESSED BY: Graffoto
PHOTO #: 48 of 54

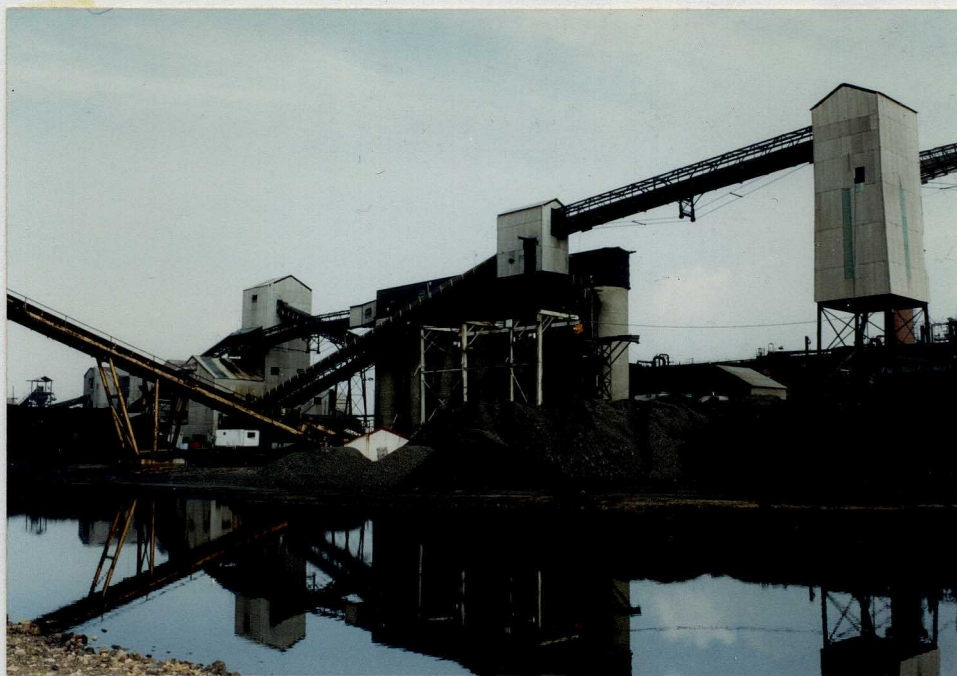
PROJECT/CASE NO: Detroit Coke VSI
SUBJECT: _____
LOCATION: Coal storage bins & conveyor system
CITY: Detroit COUNTY: Wayne STATE: MI
DATE: 7/15/92 TIME: 8:00 am - 5:00 pm
WEATHER: (SUN) (HAZE) (CLOUDY) (RAIN) (SNOW)
PHOTOGRAPHER (Sig.) Allen Melan
WITNESS: Gregory A. Rudloff
CAMERA: Freedom
FILM TYPE: K. Gold ASA 200 T: 1/____ f: _____
NEGATIVE LOCATION: U.S. EPA FILE #: _____
PROCESSED BY: Graffoto
PHOTO #: 49 of 54

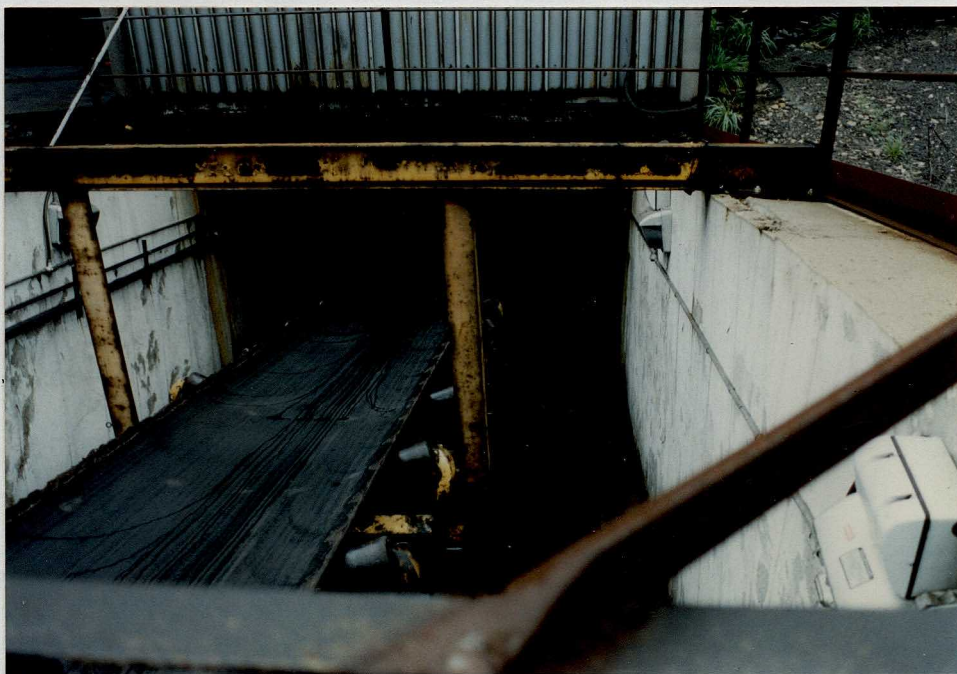
PROJECT/CASE NO: Detroit Coke VSI
SUBJECT: _____
LOCATION: Underground coal conveyor
CITY: Detroit COUNTY: Wayne STATE: MI
DATE: 7/15/92 TIME: 8:00 am - 5:00 pm
WEATHER: (SUN) (HAZE) (CLOUDY) (RAIN) (SNOW)
PHOTOGRAPHER (Sig.) Allen Melan
WITNESS: Gregory A. Rudloff
CAMERA: Freedom
FILM TYPE: K. Gold ASA 200 T: 1/____ f: _____
NEGATIVE LOCATION: U.S. EPA FILE #: _____
PROCESSED BY: Graffoto
PHOTO #: 50 of 54

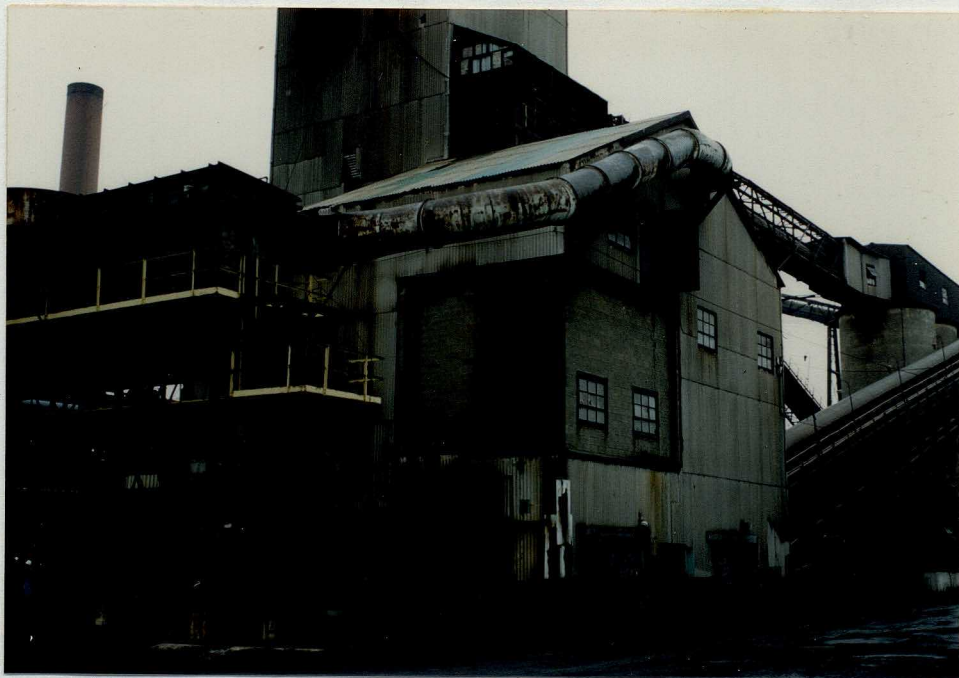
PROJECT/CASE NO: Detroit Coke VSI
SUBJECT: _____
LOCATION: Crusher building
CITY: Detroit COUNTY: Wayne STATE: MI
DATE: 7/15/92 TIME: 8:00 am - 5:00 pm
WEATHER: (SUN) (HAZE) (CLOUDY) (RAIN) (SNOW)
PHOTOGRAPHER (Sig.) Allen Melzer
WITNESS: Gregory A. Rudloff
CAMERA: Freedom
FILM TYPE: K. Gold ASA 200 T: 1/ f: _____
NEGATIVE LOCATION: U.S. EPA FILE #: _____
PROCESSED BY: Graffoto
PHOTO #: 51 of 54

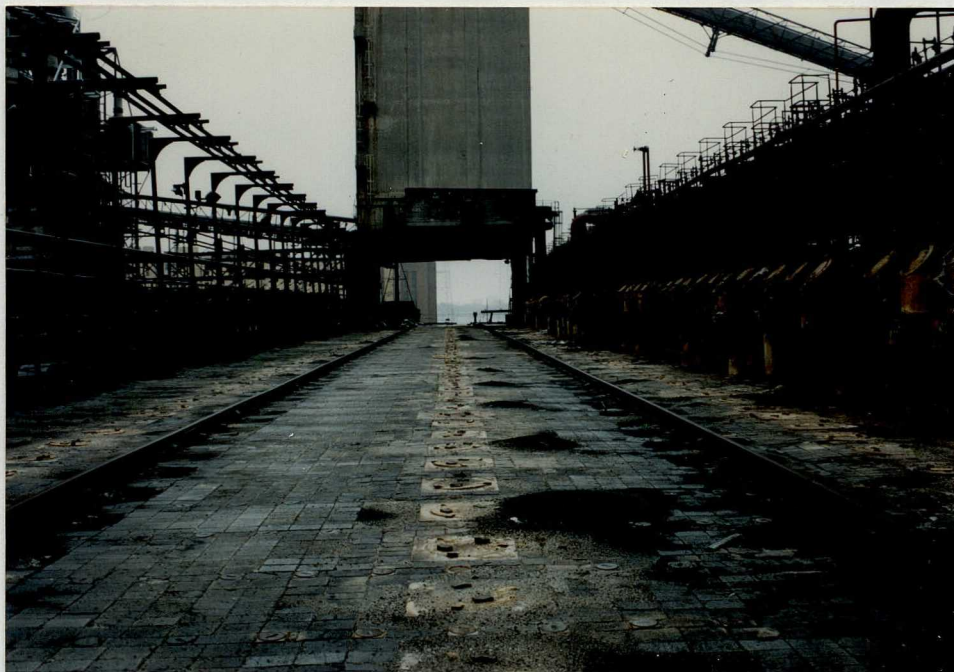
PROJECT/CASE NO: Detroit Coke VSI
SUBJECT: _____
LOCATION: Top of coke battery
CITY: Detroit COUNTY: Wayne STATE: MI
DATE: 7/15/92 TIME: 8:00 am - 5:00 pm
WEATHER: (SUN) (HAZE) (CLOUDY) (RAIN) (SNOW)
PHOTOGRAPHER (Sig.) Allen Melan
WITNESS: Gregory A. Rudloff
CAMERA: Freedom
FILM TYPE: K. Gold ASA 200 T: 1/____ F: ____
NEGATIVE LOCATION: U.S. EPA FILE #: ____
PROCESSED BY: Graffoto
PHOTO #: 53 of 54
